CMTS ID: 4150

## Physical Assessment of:

## Post Oak East Apartments

**Inspection Date: 01/25/2017**

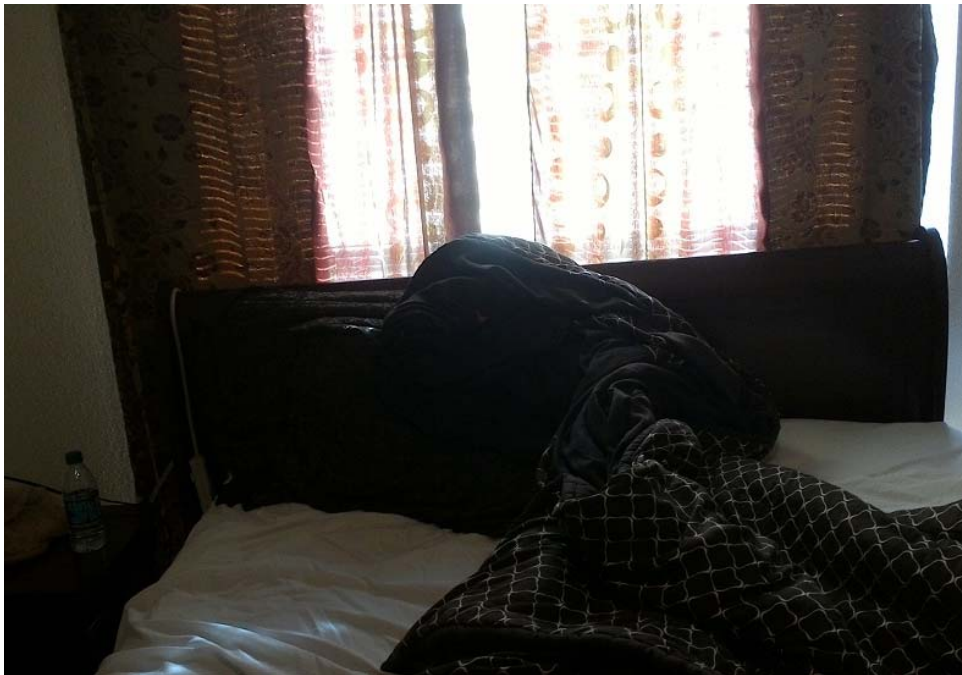
3 Blocked Egress

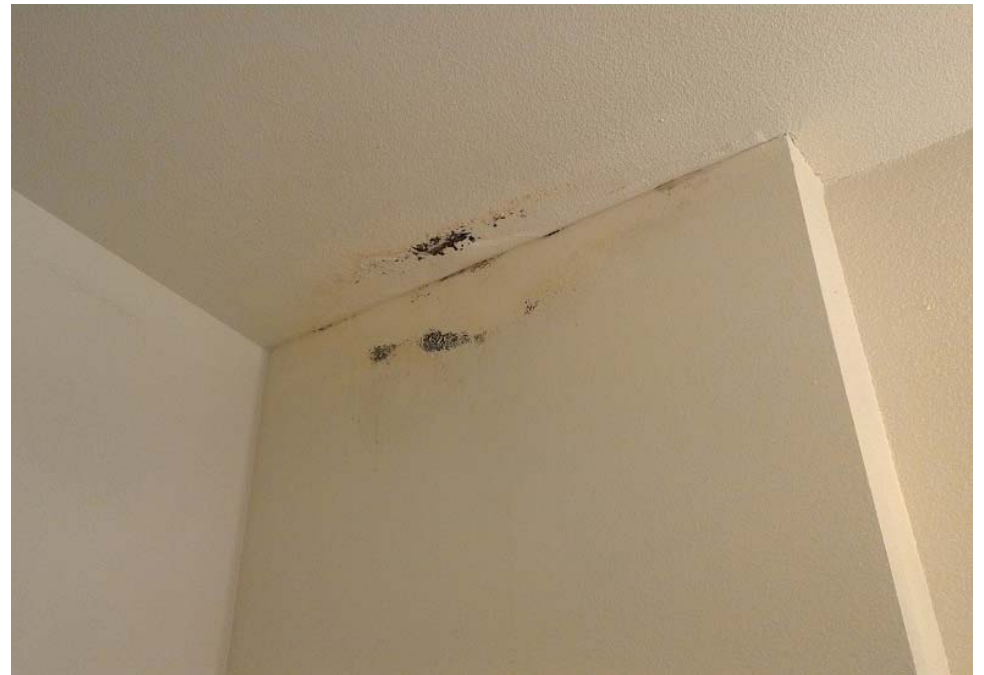
4 Ceiling wall

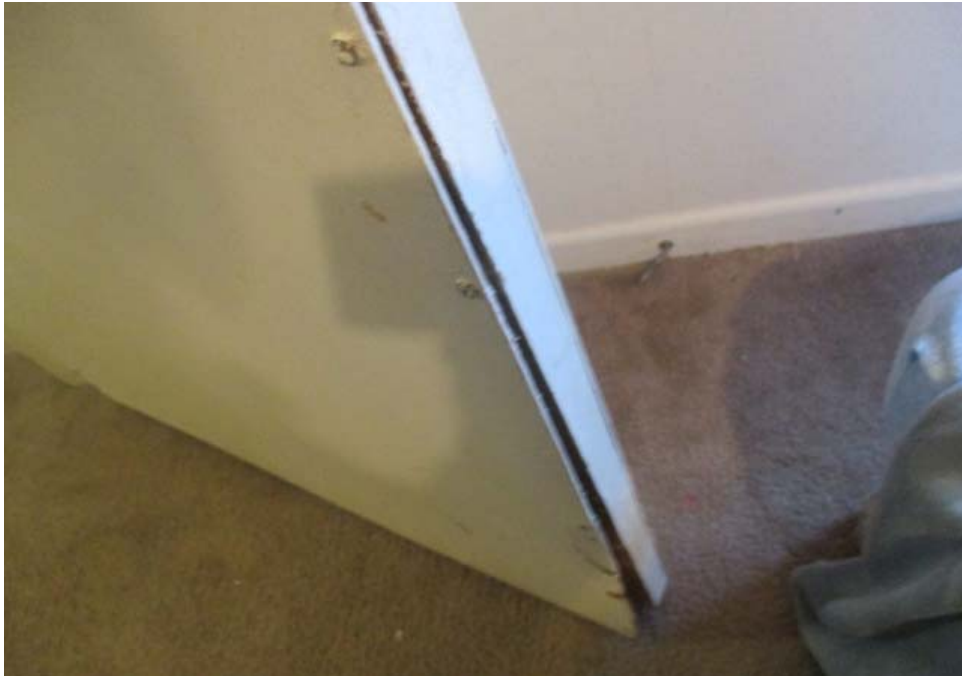
5 Door

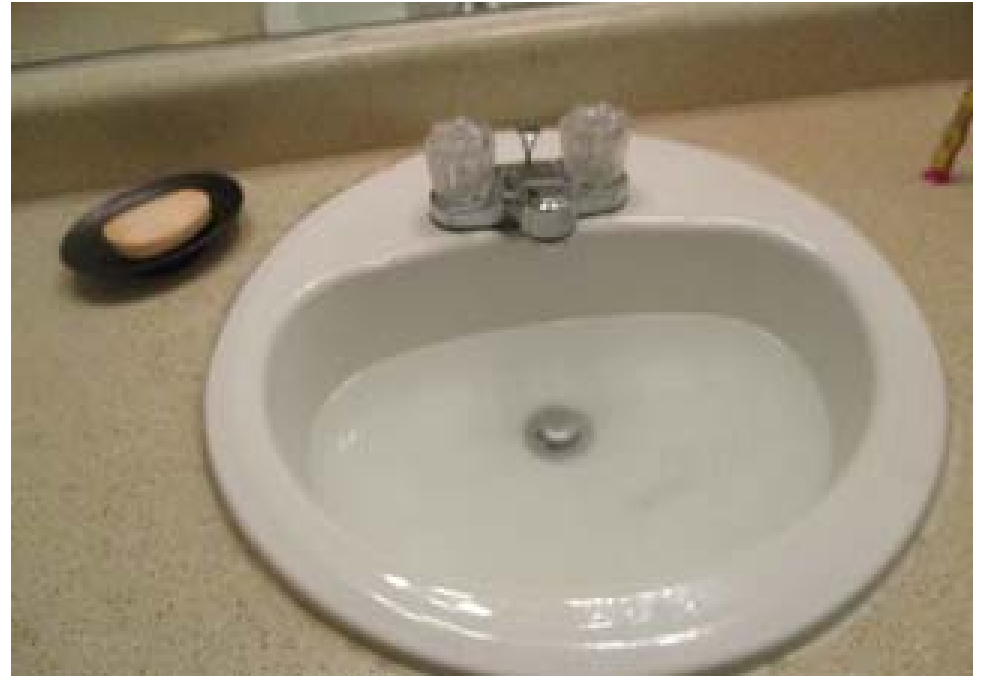
6 Drain

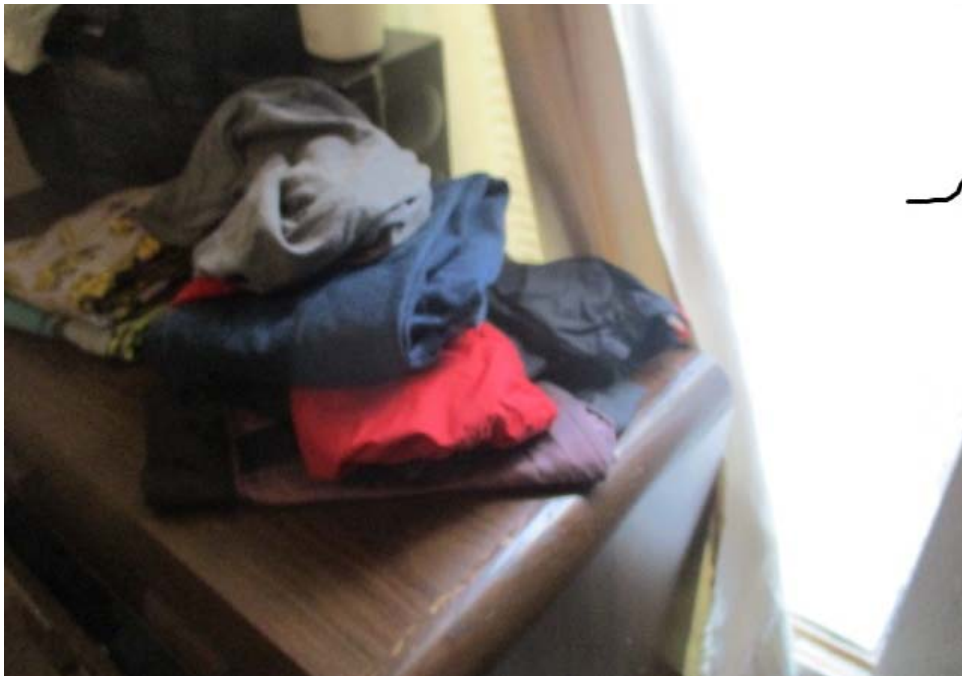
7 Egress

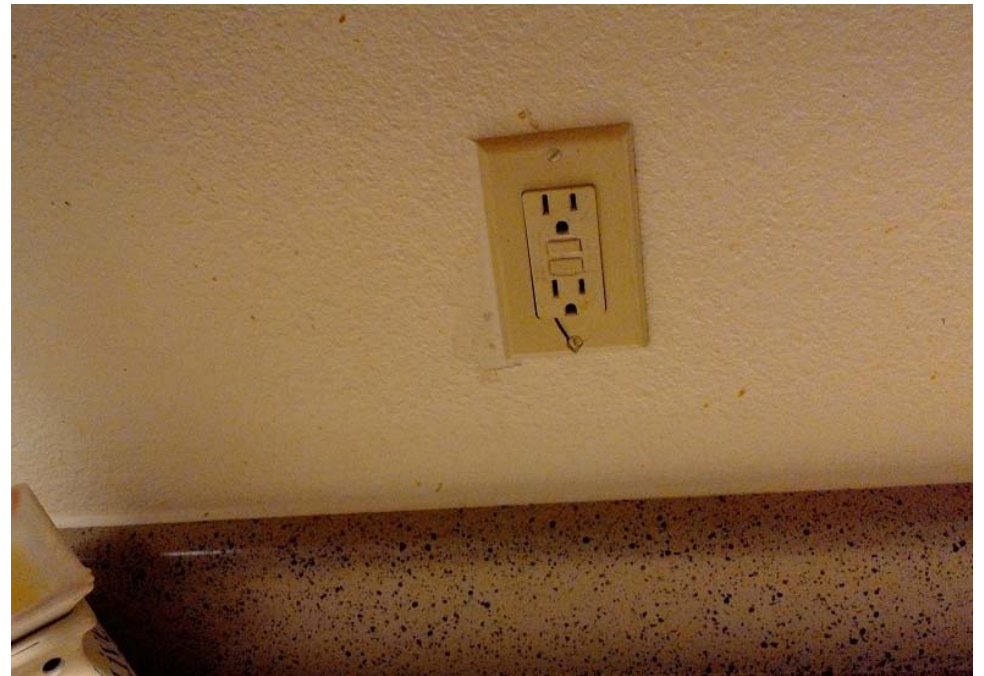
8 Electrical

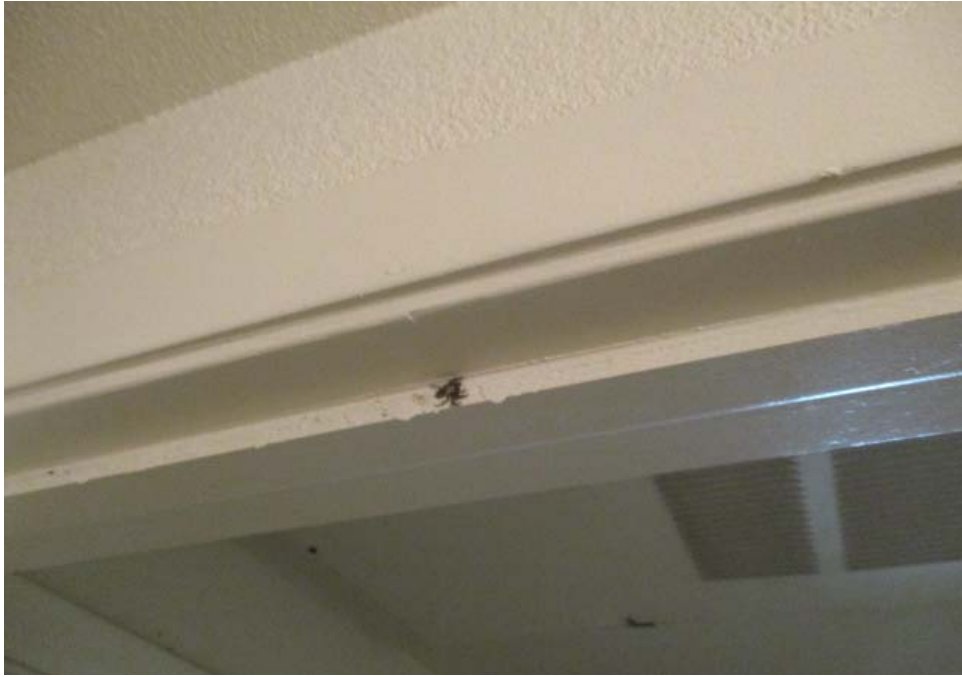
9 Infestation

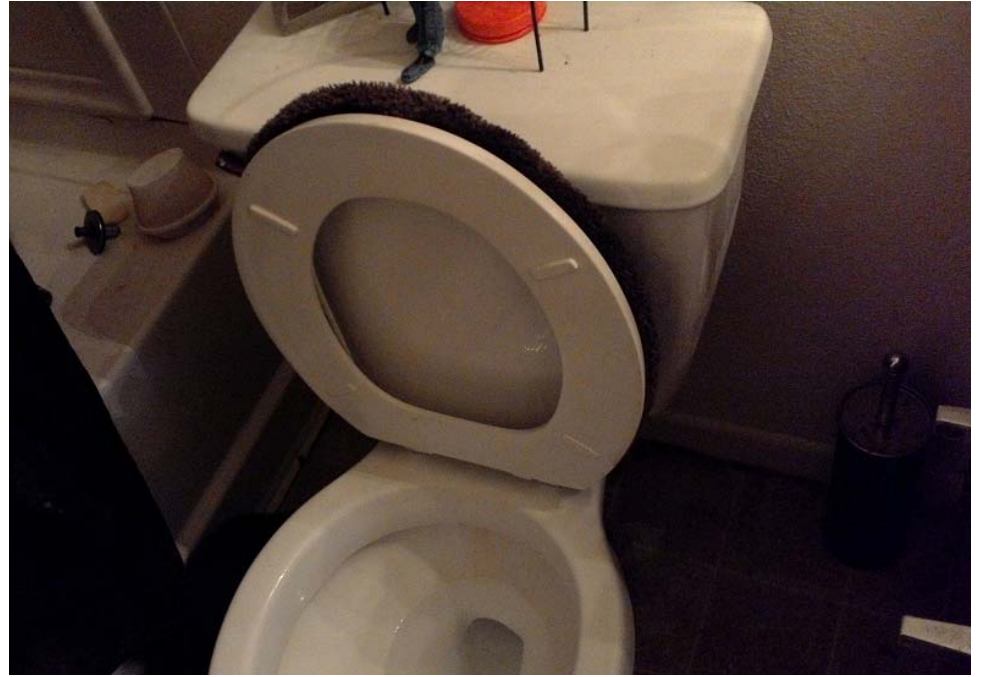
10 Plumbing

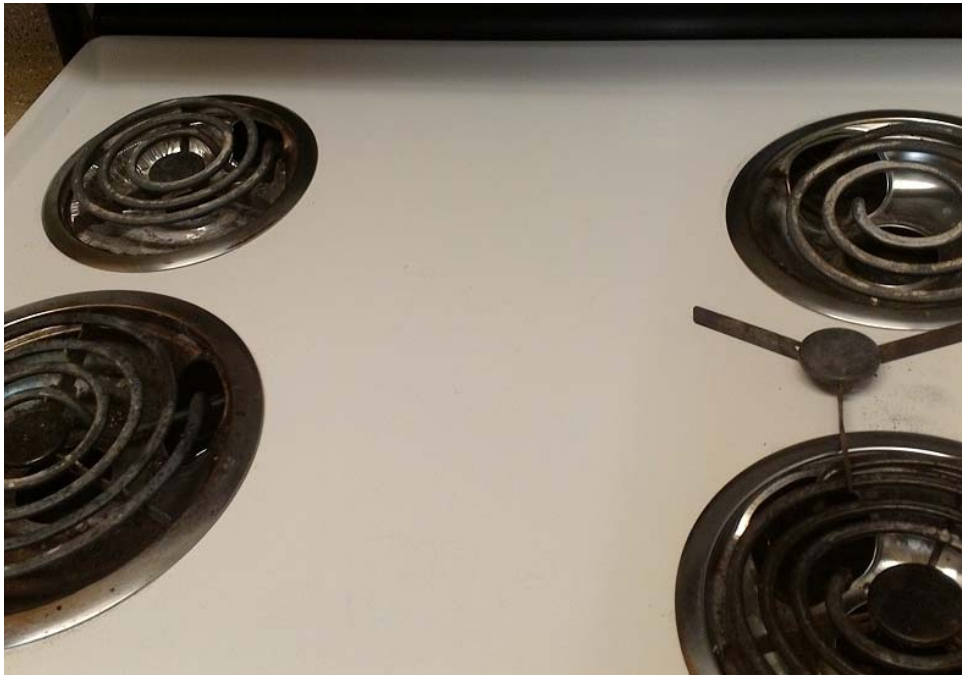
11 Stove

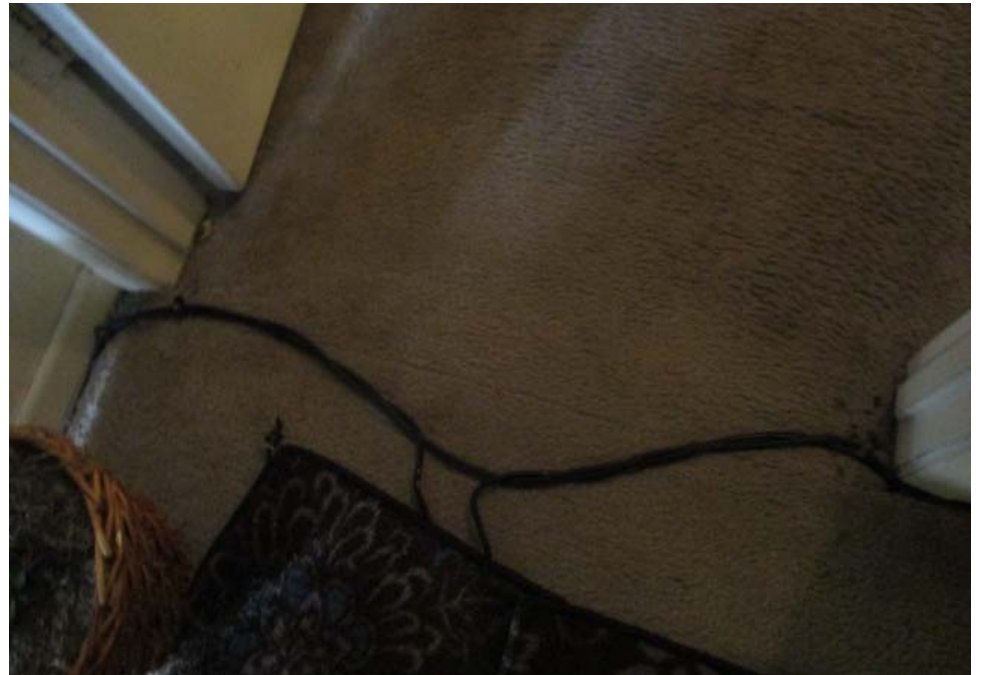
12 Trip Hazard

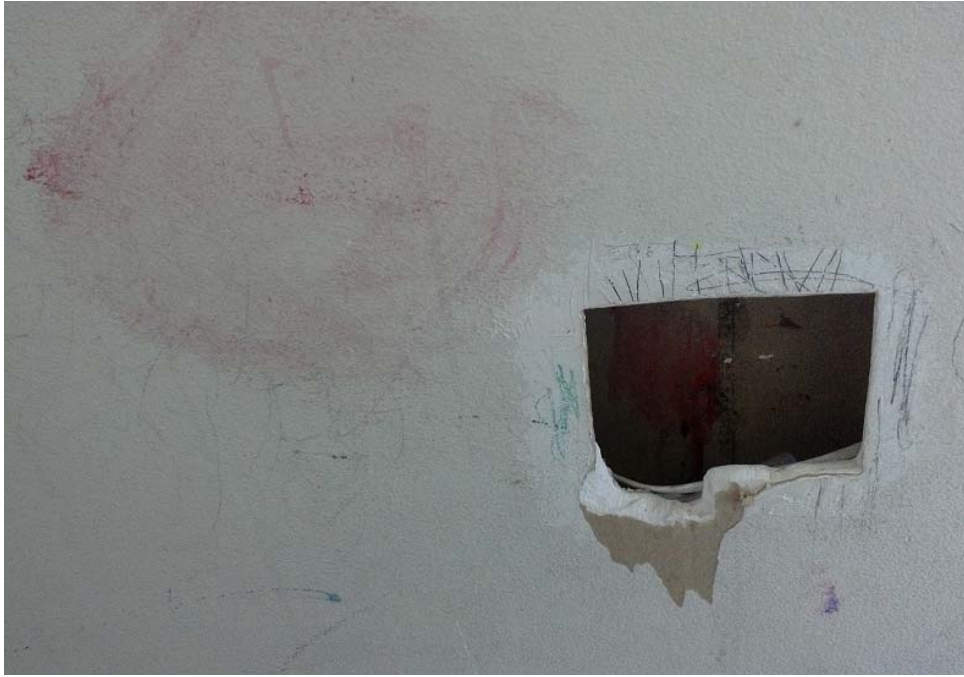
13 Wall
